# Giuseppe Damiani Almeyda's Architecture: Constructing the Modern Restoring the Ancient. The Cathedral of Marsala.

Caterina F. Carocci

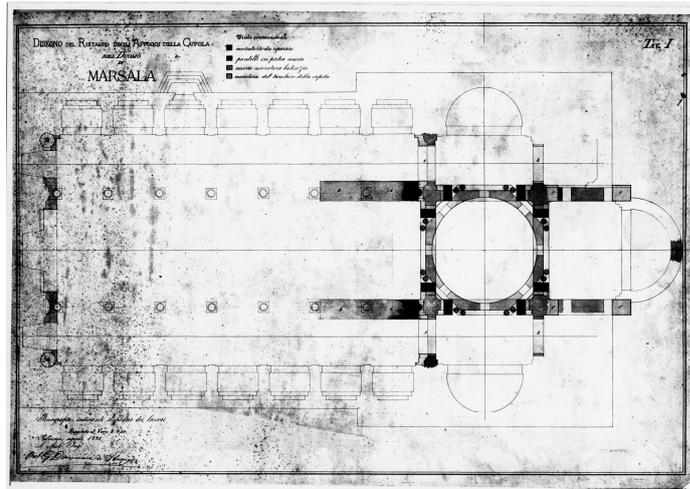
Figure 2: Restoration design of the supports of Marsala's Cathedral Dome, working plan; (DPA)

First phase: (a) repair and consolidation of the 8 walls representing the enlarged support system for the dome, building squared stone walls to close the 6 arches placed in the above mentioned walls (only the apse walls have no arches) and building buttresses in the arcades adjacent to the closed ones along the longitudinal walls of the central nave; (b) building of two pointed arches in the middle of apse walls, in order to remove the walls' load-bearing function from the most badly damaged walls (fig. 2).

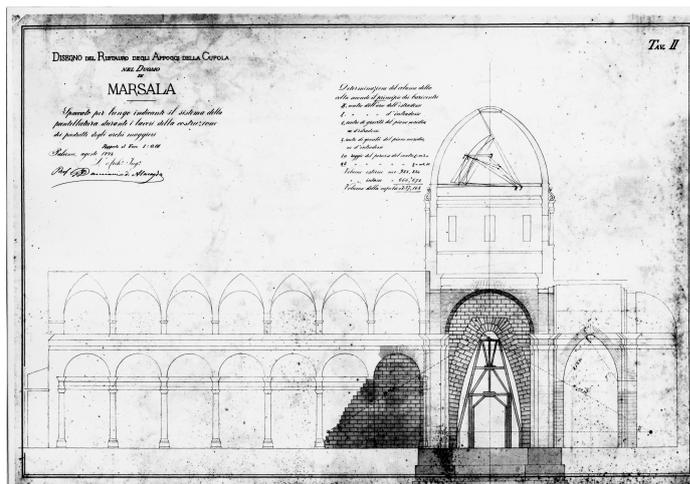
Figure 3: Longitudinal section indicating the works' propping system; (DPA)

Fourth phase: once the underpinning of the 4 pylons has been completed, they can be connected "with masonry made up of compact lime stones thoroughly covered with hydraulic mortar, carefully mixed and well-tapped with a hammer [...] thus forming in the foundations a single closed load-bearing system" (fig.3).

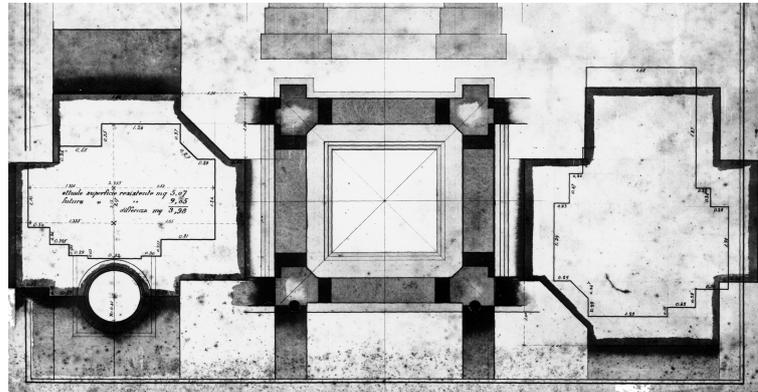
Figure 4: Details of the pylons' current state compared to the enlargement proposed by Damiani; (DPA)

Sixth phase: thickening will be first performed on the 8 pylon faces towards the main arches, by firmly toothing the added tiles. In so doing, a complete thickening of each pylon shall be carried out metre by metre, and so on, working along the area until the impost of the main arches is reached. While performing pylon thickening, the walls departing from pylons will be repaired and the cracks shall be filled in 'as deeply as possible' from the pylons (fig. 4).

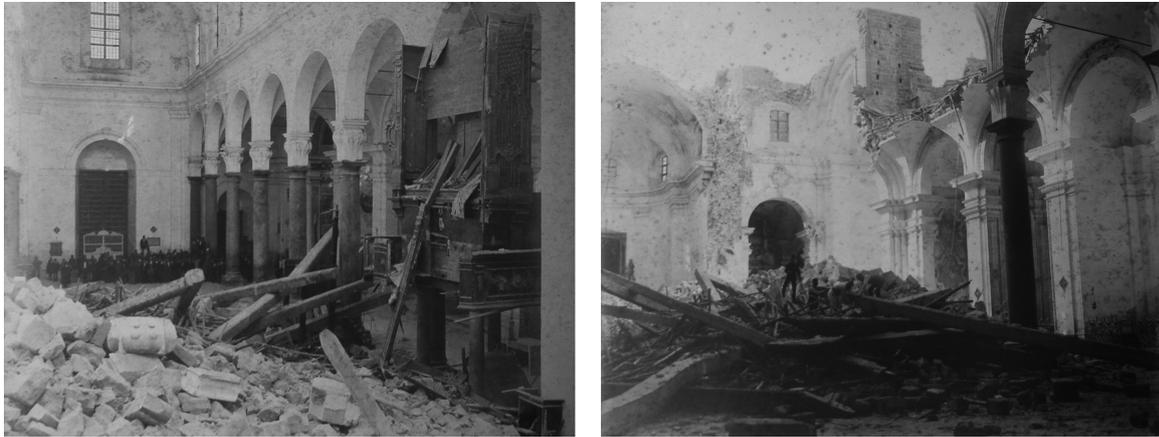
On 9 February 1893 at 10.34 am the dome collapsed without damaging the surrounding buildings, without causing any casualties, sweeping away three of the four pylons that supported it, three compact limestone columns in the nave, and about one third of the whole roofing vault. The degree of the collapse is shown by the 9 pictures kept in Damiani's archive (fig.5).

The pylon that caved in was the one on the left of the main altar; when starting the construction site during the foundation excavations to rebuild the pylon, they would find out that it was standing on a non-compact soil containing the ruins of an ancient building, and that its foundations were inadequate.

Figure 5: The collapse of the dome, looking at the main façade (left) and at the apse (right); (DPA)

Besides providing information regarding the area of the collapse, these photographic images highlight another flaw in the pylon that caved in first and initiated the collapse: the inappropriate wall structure, made of small-sized stone elements and an overabundant amount of mortar. A letter by Damiani to the mayor of Marsala (dated 10 February 1893) clarifies the engineer's attitude towards the collapse:
