## Early Predictions of Steel-Frame Deterioration: Permanency in High-Rise Construction

Donald Friedman

*Old Structures Engineering, PC, New York, United States*

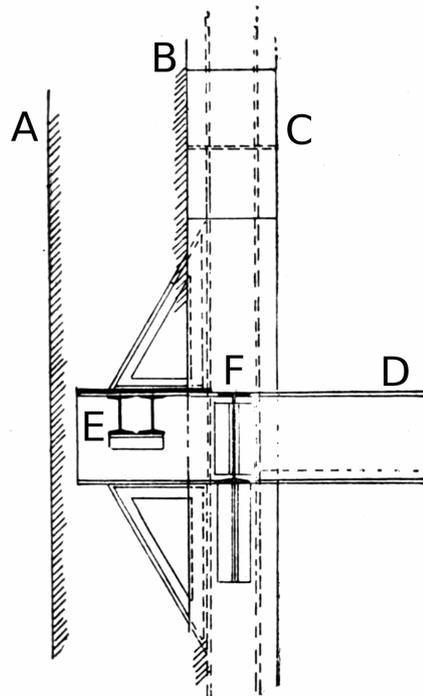
Figure 1: Exterior wall section of the St. Paul Building, showing the exterior (A) and interior (B) faces of the exterior wall, the spandrel column (C), an interior girder (D), the wall-carrying double spandrel beam (E), and the frame spandrel (F); (Birkmire 1906, p. 190)

The 1899 St. Paul Building in lower Manhattan was one of George Post's last skyscrapers and it clearly shows his conservative approach to protecting the exterior steel columns. The building occupied a small, irregularly-shaped lot and was 25 stories and 94m high, making it briefly one of the tallest buildings in the world. The structural system of the building was typical of the era in broad terms, with a steel framing supporting the masonry curtain walls and interior floors, but the details were designed to protect the columns. First, the columns were set entirely inboard of the curtain wall, so that water would have to penetrate the entire thickness of the wall before it could touch column steel. The spandrel beams carrying the wall were supported by brackets that effectively were cantilevered extensions of interior floor beams, and the columns were waterproofed by a combination of a solidly-grouted space between the steel and the terra-cotta fireproofing and asphalt-impregnated felt applied to the painted steel. Figures 1 and 2 show the relation of the wall to the steel framing in section and plan. In theory, the terra cotta and grout could be removed to permit inspection of all faces of the columns (or at least, those portions which were standing free outside of the floor structure) but there is no record of such inspections ever being performed. (Birkmire 1906, pp. 189-191; Mujica 1929, pp. 29, 59)

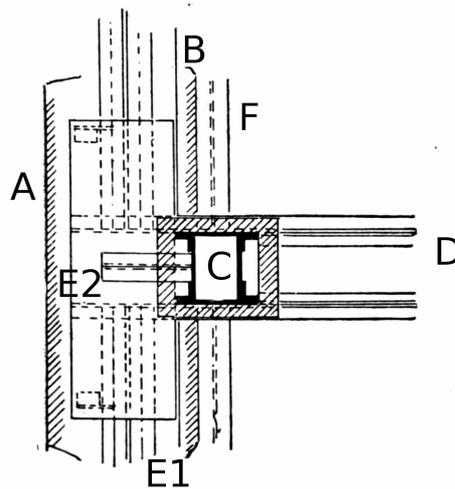
Figure 2: Exterior wall plan section of the St. Paul Building, showing the exterior (A) and interior (B) faces of the exterior wall, the spandrel column (C), an interior girder (D), the wall-carrying double spandrel beam (E1), the bracket to carry the spandrel beams (E2), and the frame spandrel (F); (Birkmire 1906, p. 190)

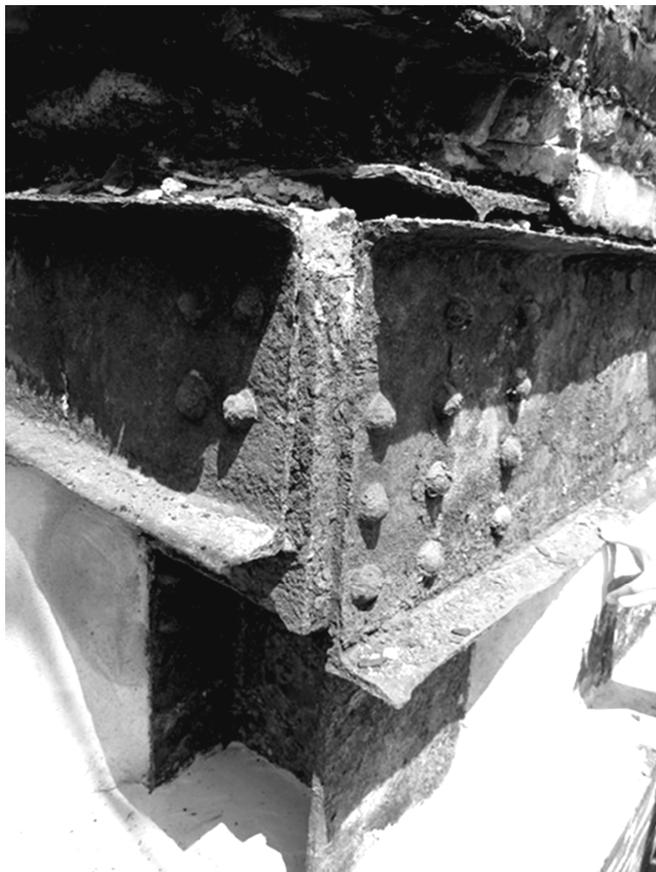
Figure 3: Author's photograph of a corner column at 720 Park Avenue, New York. The white is temporary protection where masonry has been removed; the removal shows two channel spandrel beams and a wide-flange column.

Engineers and architects performing examinations under these laws have found that steel deterioration is common to all of the steel embedded with exterior walls: beams, columns, connections, and the secondary members used to support ornamental masonry. Figure 3 shows two spandrel beams and a column, all with severely pitted surfaces and material loss from corrosion. Horizontal surfaces, such as the flanges of beams or the tops of bracketed connections, appear to be the most vulnerable as water traveling within the masonry can sit on these surfaces for long period of times. Paint has been found to inevitably fail: beams are often found to have paint intact in areas from which water drains and paint missing in areas where water pools. Figure 4 shows a spandrel beam with intact paint on the upper portion of its web despite corrosion on the lower web and bottom flange.

During nearly thirty years of organized facade inspection in New York, corroded steel has led to every outcome from full steel repair and historically-accurate recreation of the masonry removed for access (many buildings, including 720 Park Avenue, shown in Figures 3, 4, and 5) to complete removal of the ornamental masonry (as at the now-demolished Mayflower Hotel). When steel repairs are required, designers must answer the question of how to protect the steel against future corrosion. One of the popular solutions is to paint the steel and then coat it with Bithuthane, a brand-name asphalt-impregnated cloth that is essentially similar to the "asphalted felt" that George Post used on the St. Paul Building and recommended for use on all steel frames.

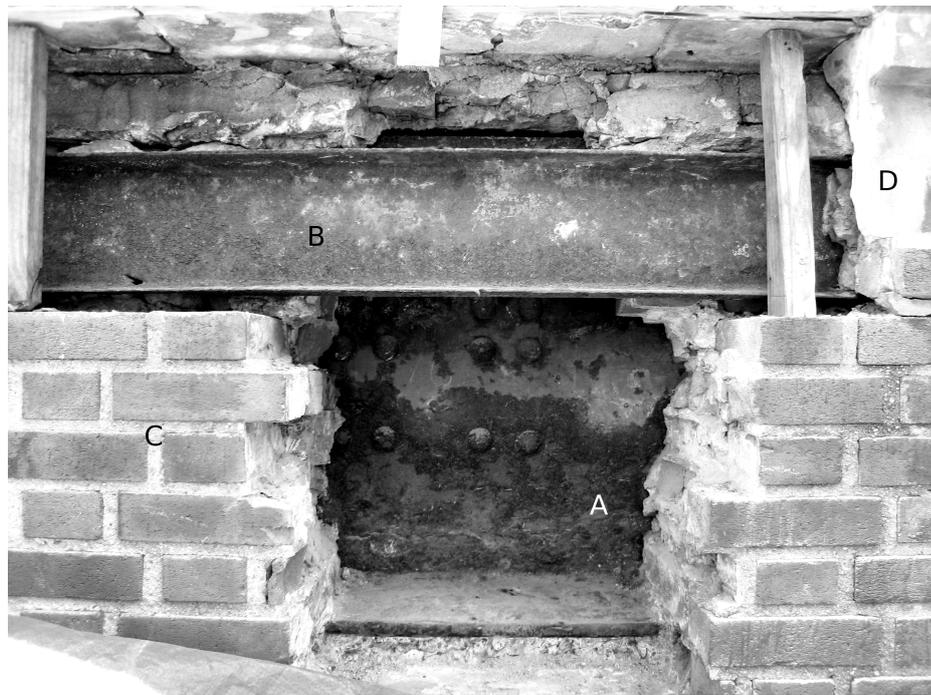
Figure 4: Author's photograph of a wall probe at 720 Park Avenue. The main spandrel beam (A) has intact paint on the upper portion of its web and rusting on the lower web and bottom flange, despite being set back from the wall face (C). The secondary beam (B) that stabilizes the cornice (D) is heavily rusted.

Steel corrosion threatens public safety and buildings' long-term stability in two ways: first, by weakening the structural frame to the point where collapse is possible, and second by cracking and displacing curtain-wall masonry through the mechanism of rust-jacking. (n.a. 1978) The second danger is far more prevalent than the first, and is actually considered helpful during investigations. Initial investigation take place with the curtain walls intact and masonry is removed only when there is a reason to suspect steel damage at a specific location. The effects of rust-jacking often provide that reason, and probes are cut where cracks and displacement are noted. Figure 5 shows the crack adjacent to the masonry-removal probe shown in Figure 4.

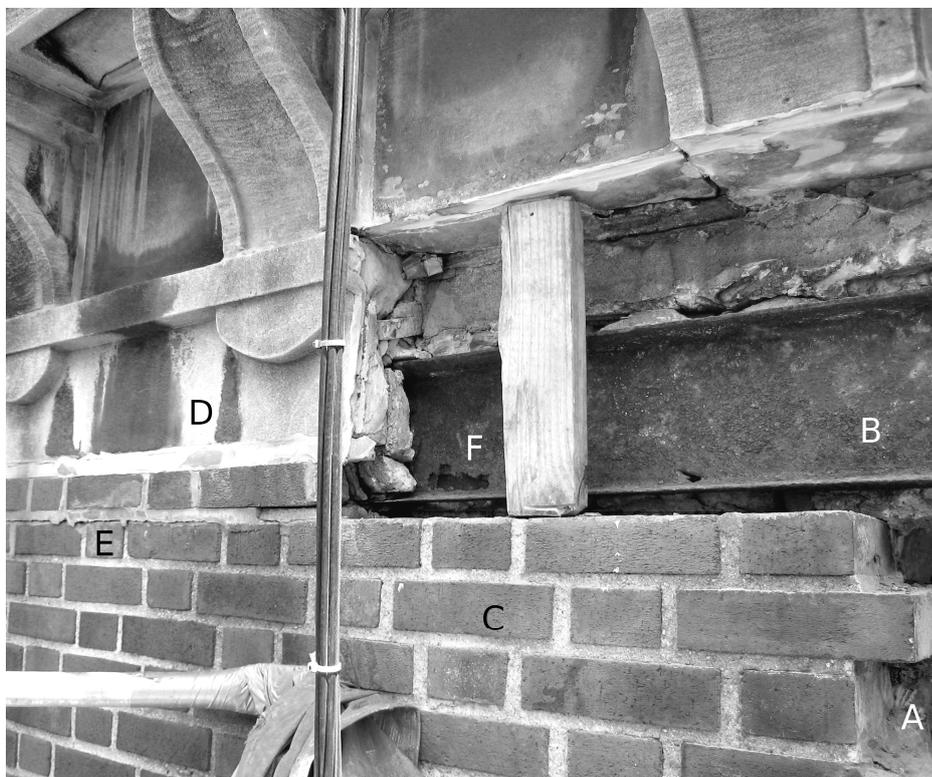
Figure 5: Author's photograph of a wall probe at 720 Park Avenue, immediately adjacent to Figure 4. The web of the secondary beam is rusted completely through (F) suggesting further removals are required. The probe was located based on the crack (E) in the visible face of the wall (C).
