Refurbishment of Industrial Buildings in Early Reinforced Concrete

ABSTRACT: The presence of François Hennebique in Belgium until 1896 certainly urged the use and spread of reinforced concrete as a building system in Belgium. Although numerous buildings were erected, not much of them have survived the 21st century. The early witnesses are now protected as historical monument. However, their refurbishment is a long and difficult process. The paper explores in depth the architectural and technical design process of two renovated industrial buildings in Belgium: the *Vuurmolen* (1902) in Overijse constructed according to the M. Dumas patent, and the *Royal Entrepot* (1903-6) in Brussels, constructed according to the Hennebique patent. By going into the construction history, re-use, assessment, strengthening and thermal upgrading, it becomes clear that there are no standard procedures for the rehabilitation of these multiform early industrial concrete buildings.

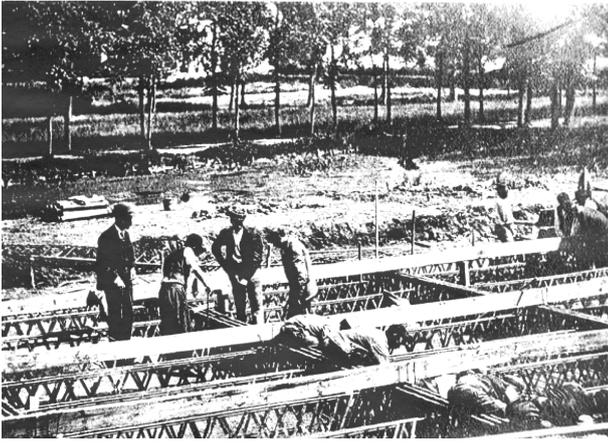
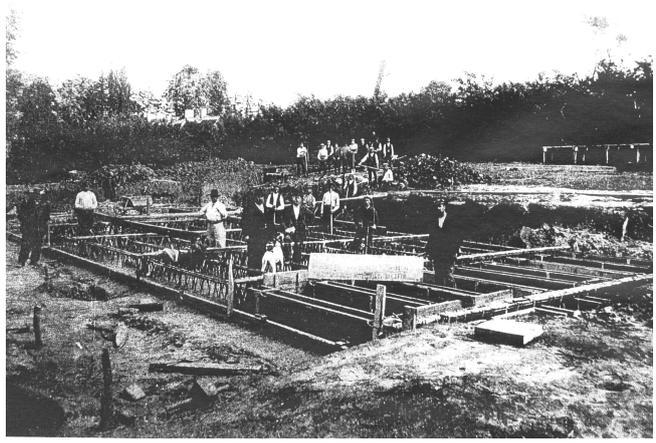
Figure 1: Vuurmolen. Foundations in reinforced concrete of the flour-mill at Overijse in summer 1902 (Photo Archive R. De Coster)

Neither original plans nor drawings of the building are preserved, but one can base on early construction photographs to date back the building and gain insight into the used reinforcement system. A photograph with hand drawn date 21 June 1902 shows the developer, Mr. Decoster, between the building workers on the building yard (Fig. 1). The photograph shows the footprint of the building which measures 17.5 m by 9 m. The dense structural grid of primary and secondary beams is visible (1.50 m by 3.50 m). At the moment the picture was taken, the concrete slab has been poured and workers are setting up the timber formwork around the reinforcement of the inverted foundation beams. Although the pictures do not show the reinforcement in detail, the diagonal stirrups strips catch the eye. This arrangement of the reinforcement comes close to the patented system of the engineer Maurice Dumas. And indeed, the hardly visible text on the board in the photograph mentions: ... STEVENS DECOSTER, BETON ARME SYSTEME PERRAUD DUMAS, LEON MONNOYER CONSTRUCTEUR, BRUXELLES (Ackers, 2005, p. 142).

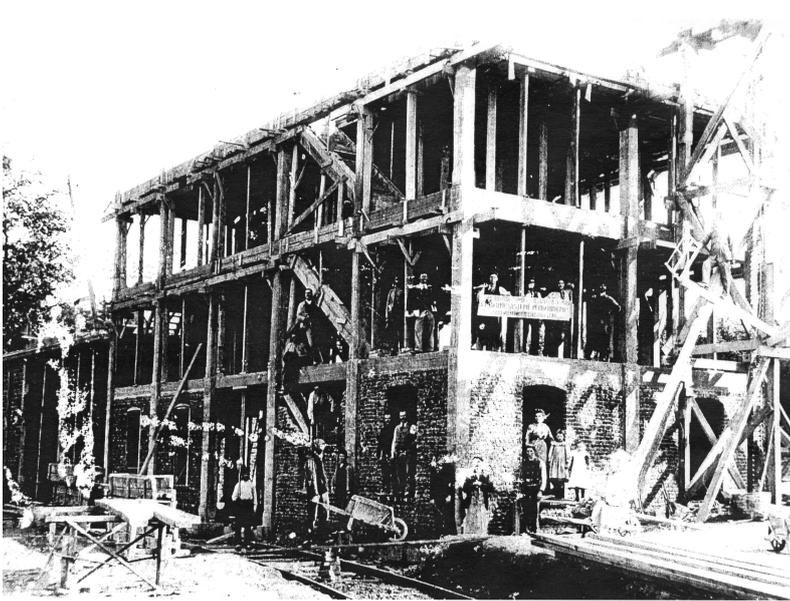
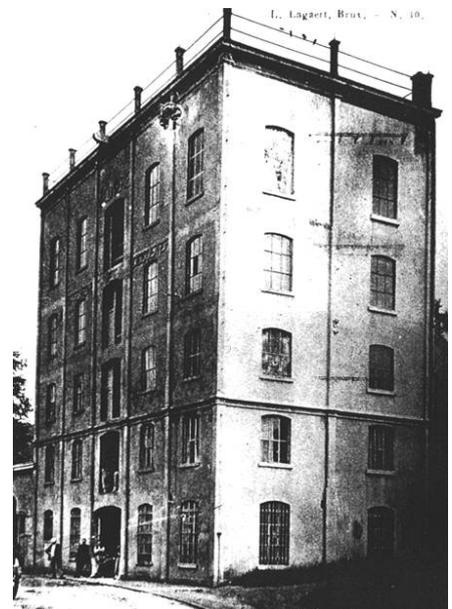
Figure 2: Vuurmolen. Reinforced concrete frame with brick infill (left) and completed (right) (Photo archive R. De Coster)

The cement plastered façade and the characteristic steel windows had to be conserved. To upgrade the thermal capacity of the wall, which was constructed as a concrete frame with brick infill (Fig.2), insulation boards were attached to the inside of the wall. A second window is placed at the inside of the original steel window. To reduce the thermal bridge close to the concrete floor slab, a horizontal thermal insulation board is fixed onto the ceiling, into the first bay. On top of this, an acoustic insulation board is applied. This way, the level of the ceiling is lowered and the proportions of the primary and secondary beams get lost, leading to a somewhat estranged experience (Fig. 4b, 5b). However, from outside the intervention of the thermal upgrading is (almost) invisible.

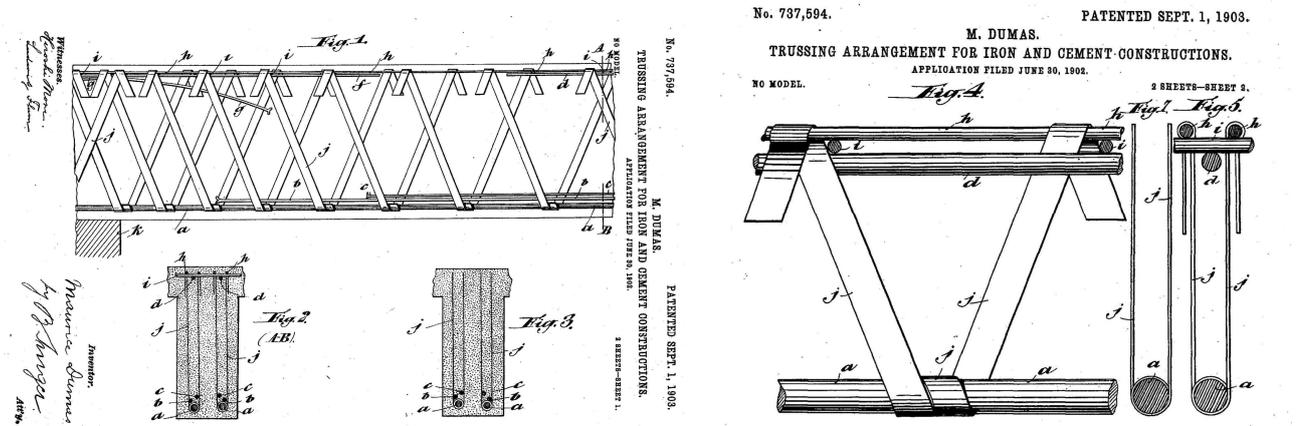
Figure 3: Patent 'trussing arrangement for iron and cement constructions' from Maurice Dumas (Patent 1903)

In his patent '*trussing arrangement for iron and cement constructions*', sent to the United States Patent Office in June 1902, the inventor Maurice Dumas, at that moment citizen of the French Republic, residing at Brussels, describes the different parts of his lattice formwork. Figure 2 shows his patent and the arrangement of the reinforcement in a simple beam. Dumas distinguished five kinds of bars. The main guide-bar (assigned the letter a in fig. 3), a round bar, runs trough the whole length of the beam and takes up the tension forces. If necessary, additional longitudinal bars (b, c, d, f, g) can be placed into the tension and the compression zone of the concrete beam to furnish the necessary resistance. Flat strips (j) are wound around the main guide-bar to form the trellis-work. Close to the support, the distance between the strips decreases to resist the shear forces.

By removing the cracked concrete from the primary beams in the Vuurmolen, one could determine the diameters of the bars (De Schutter, 2001). Using the same terminology as in the patent of M. Dumas to describe the construction, the main guide-bar (a) has a diameter of 20 mm. As on fig. 2, two bars are placed next to each other. The additional bars (b, c) are positioned on top of the guide-bar. They have a diameter of 12 mm. The secondary beam, also doubled, has a guide-bar of diameter 16 mm. No additional bars are applied here. The strips (25 mm by 2 mm) are positioned every 25 cm. At the supports, the field with increased strips is small, in fact only the last field has one additional strip, leading to an intermediate distance of 10 cm. As a consequence the resistance to shear force in the area of the supports is limited. The visual inspection of the beams indeed revealed the typical crack pattern for shear failure (De Schutter, 2001).

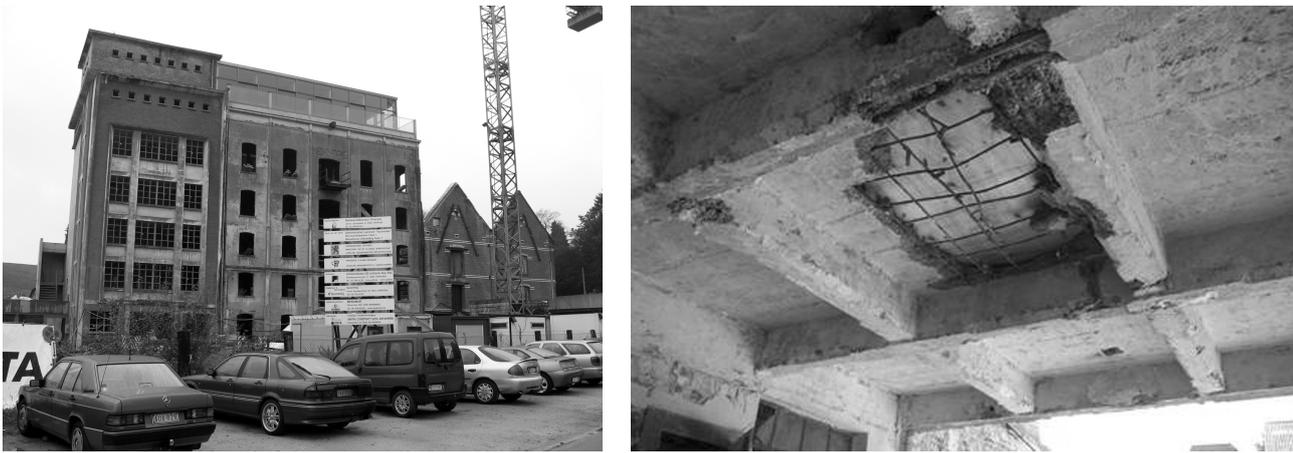
Figure 4: Vuurmolen. Building site during renovation 2003 (left). Exposure of the reinforcement in the primary and secondary beam and in the slab (right).

The refurbishment of the three industrial mill buildings, dating back from 1902, the 1920's and the 1950's, into administrative centre was not evident. Not only because the program asked for more space than there was available in the existing buildings, but especially because the circulation inside the building was not suited for other than industrial functions. Opening up the building to the public included tightened regulations concerning the accessibility and fire safety. The structure of the reinforced concrete building would have changed drastically if one would have tried to insert accurate circulation into this volume. The decision to open up the backside of the building and add a new construction to provide the circulation, made it possible to preserve the listed building and conserve the characteristic façade (Fig. 3, 4).

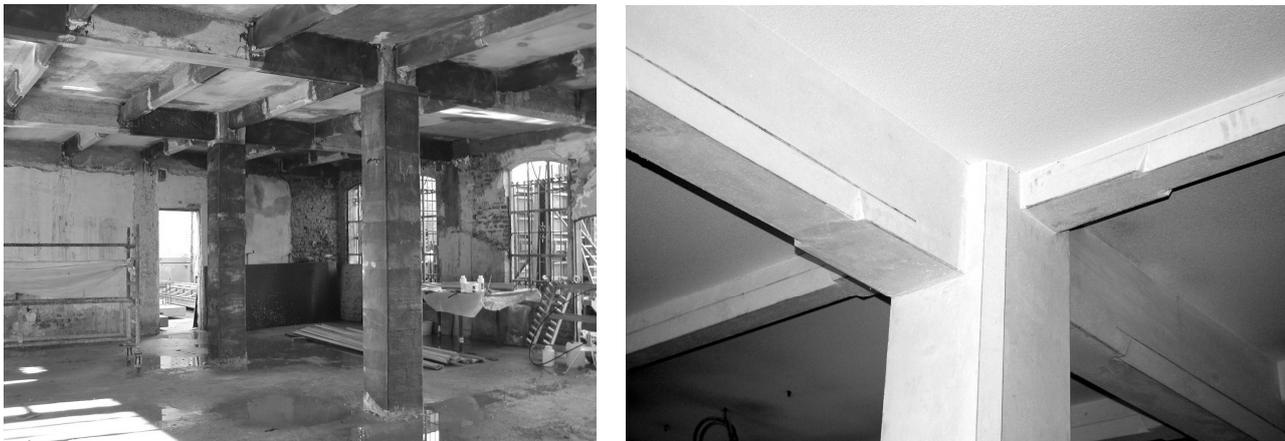
Figure 5: Vuurmolen. Strengthening of the beams and columns of with CFRP layers (left). Lowered ceiling after renovation in 2008. Columns and beams are plastered. (right).

The damaged or missing reinforcement and concrete was first repaired. Close to the supports, the beams were covered with carbon fiber reinforced plastic (CFRP) to increase the resistance against shear (Fig. 5). The bending resistance at mid span of the beam was increased by gluing a steel plate underneath the beams. While strengthening, attention was paid not to hide the original characteristic geometry (corners) of the beams and columns. The columns were wrapped in CFRP layers to increase the axial capacity. Additional steel strips were applied to increase the resistance to bending induced by wind loading. The concrete slabs are strengthened with a new lightweight concrete deck, which works as an extended compression zone, fixed to the existing beams with dowels (Winey, 2006).

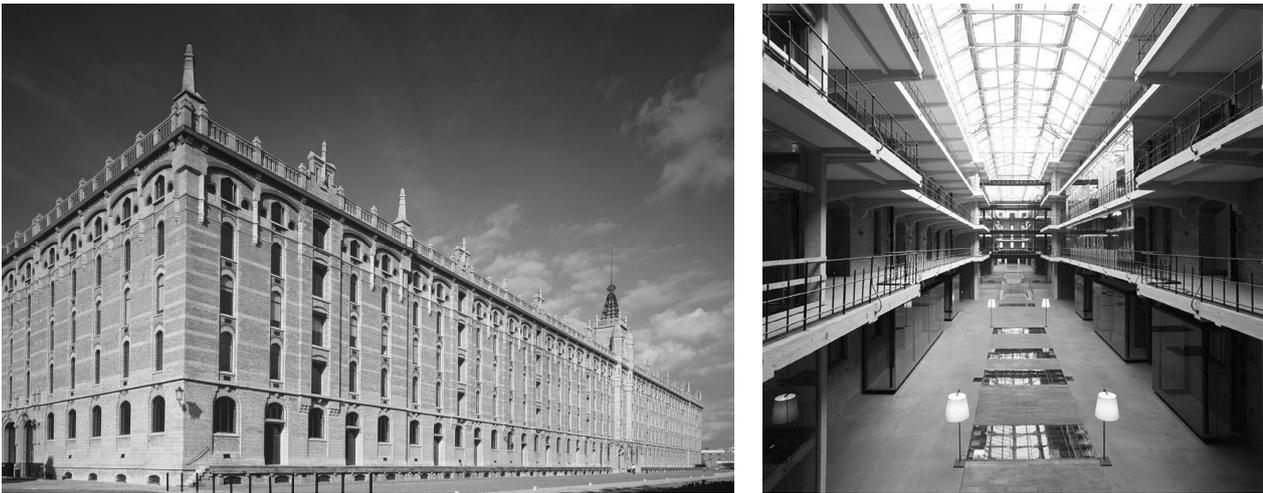
Figure 6: Warehouse Tour&Taxis. Inside and outside view after rehabilitation (Project T&T)

In the 1890's Brussels was looking for a place to built a new seaport quarter. Their eye felt on a piece of land outside the city walls. The 37 ha large plot, once owned by the family Von Thurn und Tassis, later called Tour & Taxis, was situated next to the canal, the railway and important roads. The buildings erected on this site (the maritime station, the hotel for administration, the Entrepot Royal, the storehouses, a.o.) are all masterly examples of engineering: when walking in the buildings one can admire the enormous spans, the beauty of the steel trusses, the elegance of the concrete spans. When leaving the building, on the contrary, this engineering beauty is hidden by brick façades. This need to hide the structure reveals that there was still a long way to go before reinforced concrete was recognized by architects not only as a structural interesting, but also as a beautiful and inspiring material (Fig 6).

The large structural grid (400 x 430 cm) and the high load capacity create many possibilities for re-use. Nevertheless, the small window openings and the fire safety design of the atrium need special attention. Being part of a large sea port quarter, the rehabilitation of the complex took a long time since one insisted on a global vision on the site and there was much resistance from the local residents. In 2001 *project T&T* together with *Archi 2000* architects rehabilitated the *Entrepot Royal* into offices. On the ground level an interior street with shops and restaurants is located. (Fig 6b)

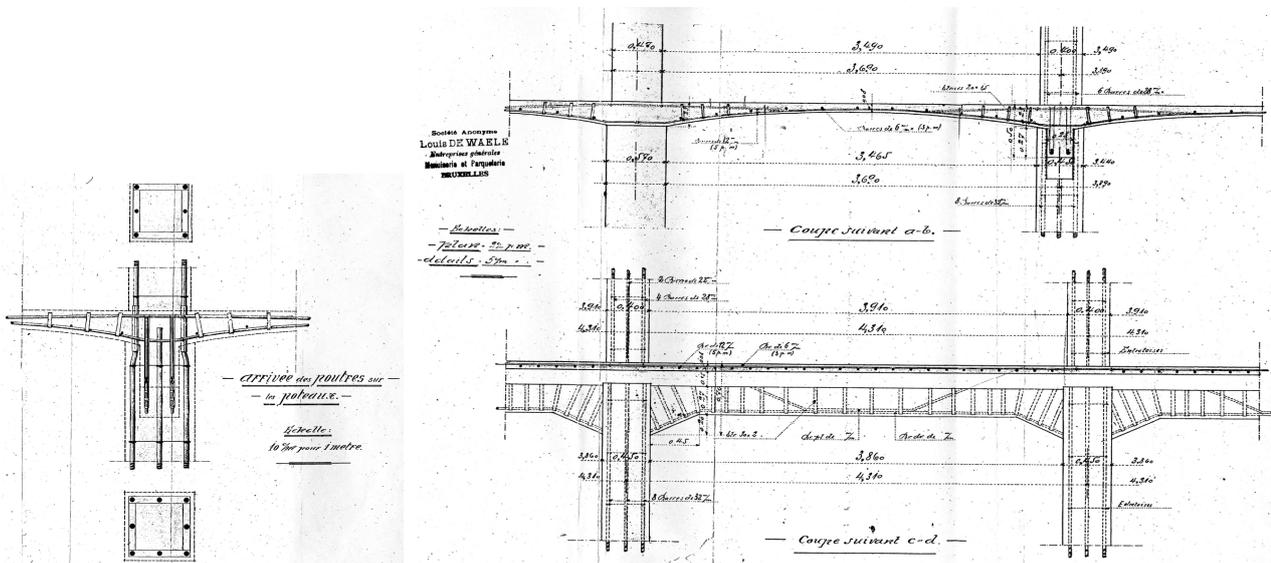
Figure 7: Warehouse Tour&Taxis. Construction details of the reinforcement by François Hennebique: column (left) and arched floors (right) (Archives n.v. Zeekanaal en Haveninrichting)

All the construction plans and even the calculation notes are conserved by the harbor authority *n.v. Zeekanaal en Haveninrichting*. The floors are built up with reinforced concrete slabs (Fig. 7). The slabs are not designed as a two-dimensional plate, but as flat arches, spanning 400 cm. The thickness of the reinforced concrete arch increases from 8 cm in the middle to 29 cm at the ends. The beams span 430 cm and rest on concrete columns.

These construction details remind the 1842-7 warehouse which was built with brick arches spanning 375 cm, with a thickness increasing from 30 cm in the middle until 78 cm at the ends, resting on cast iron beams with a span of 610 cm. Therefore, the advantage of building in reinforced concrete (compared to brick vaults) does not lie in the increasing of the span of the beams but in the slenderness and lightness of the floor.

The dimensions of the columns increase from 20 by 20 cm on the upper floor to 55 by 55 cm in the basement. The applied diameters of the reinforcement bars go from 40 mm in the basement columns over 38, 32, 28, 22 to 16 mm in the upper columns. The floors were designed to stand heavy loads (10 kN/m²) since all kinds of merchandise had to be stocked.

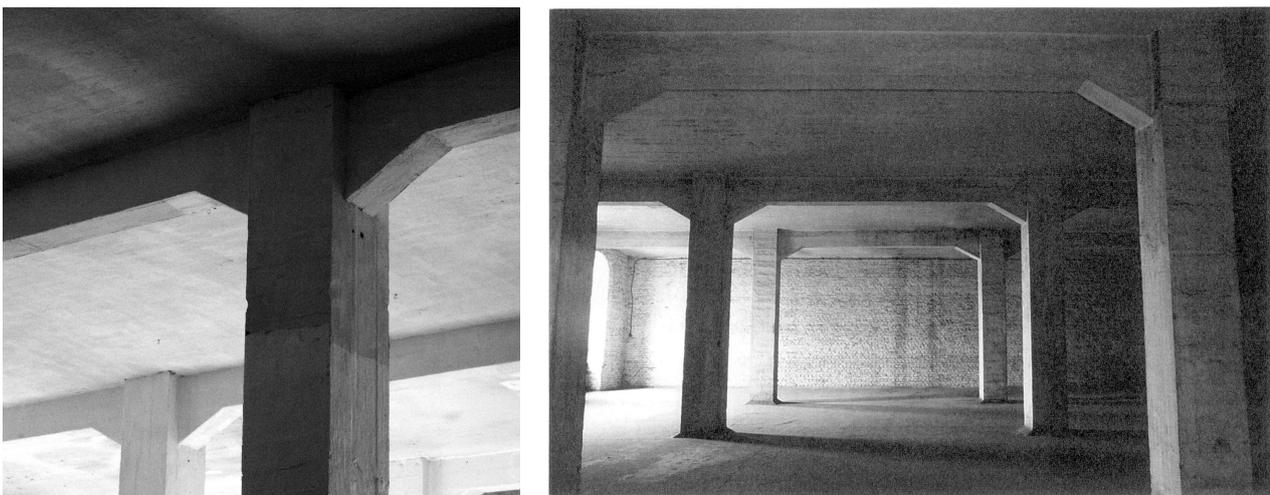
Figure 8: Warehouse Tour&Taxis. Inside view in the storage rooms before renovation (1998). The vaulted reinforced concrete floor slabs are supported by beams and columns.
