The Structure of Georgian London Houses

Paul Bell

Jampel, Davison & Bell, Consulting Engineers, London, U.K.

ABSTRACT: The influence of the Building Acts, the Great Estates and Pattern Books on the construction of Georgian London houses is considered. The separate structural elements are then assessed – foundations, vaults, external and party walls, internal timber stud walls, the differing types of floors for the various house sizes and types, roofs, staircases and chimneys. These are illustrated by examples encountered during the author's work as a structural engineer in the city.

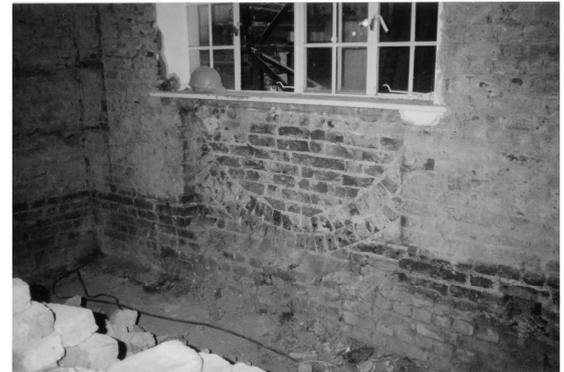
Figure 2: Inverted Arch Foundation. Nicholson 1823 Plate LXXXV (left). Albert Street Example (right).

The pattern books advocate the use of inverted arch foundations (also Pasley 1826 p.22) and one finds built examples of this technique (Fig.2). The modern engineer needs to consider the possible harmful effect of removing the panels under basement windows, particularly on clay, since this will cause increased local bearing pressure.

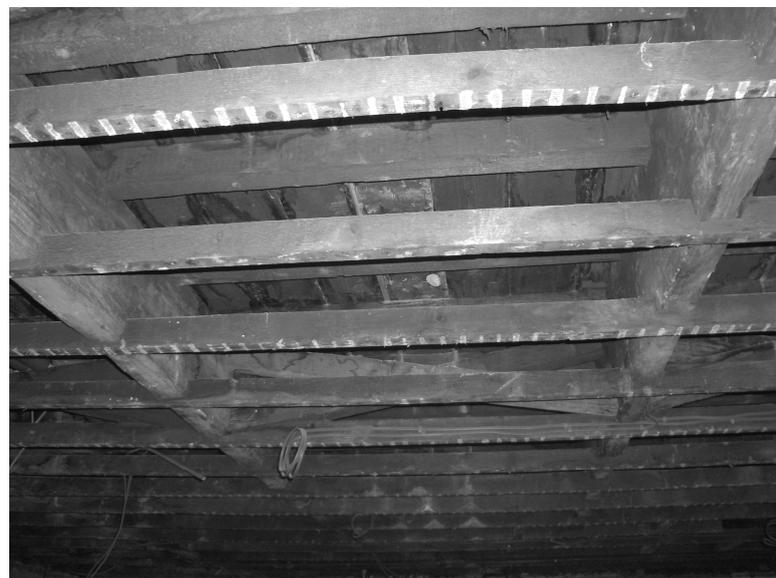
Figure 6: Floor Kent Terrace – a rare example following Nicholson (Fig.5 left).

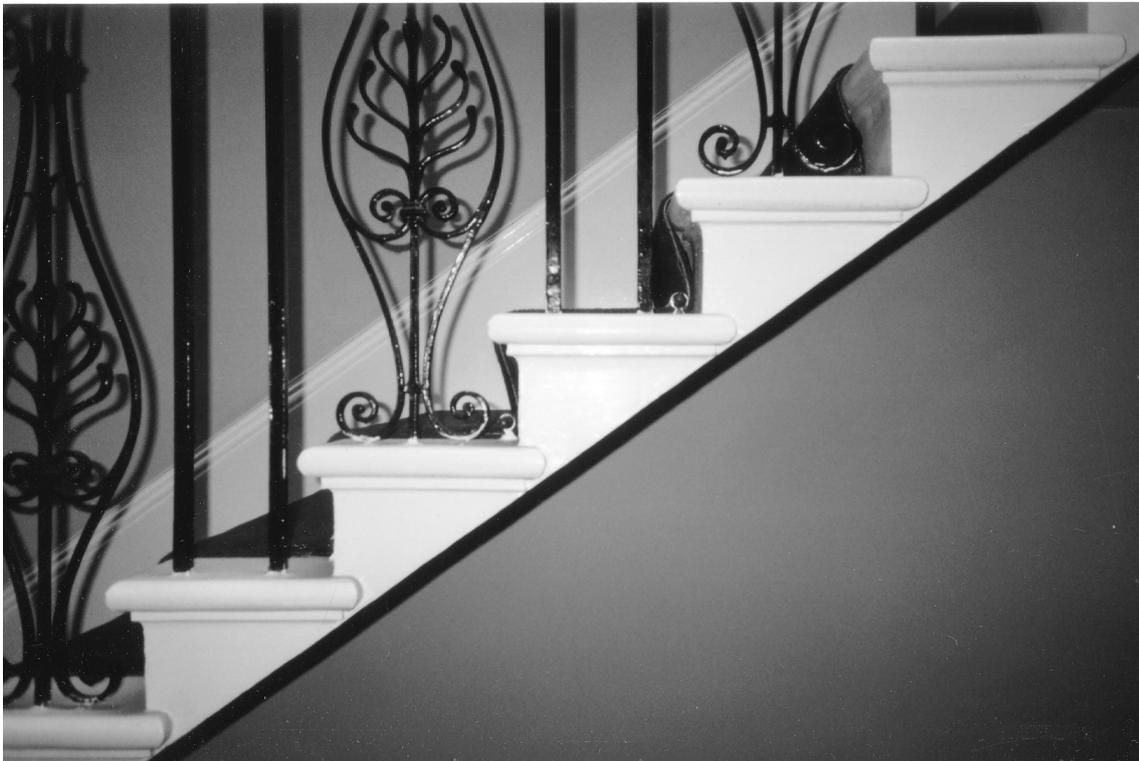
Figure 9: Cantilever Stone Stair 29 Portland Place.

The lower flights of the stairs of the larger houses were generally stone cantilevers (Fig.7). The walls surrounding these stairs were brick up to the top level of the stone stair, which was housed into them.

Much has been written about the possible modes of structural behaviour of this type of stair. The lower treads/risers provide support so that the pure cantilever is apparent rather than real (Price and Rogers 2005 p.29). The most problematic elements can be the stone landing slabs where there is little possibility of anything but cantilever action.
